D2327.001  
June 15, 2022

Re: Phase I Environmental Site Assessment ("ESA")  
730 Buck Road  
(Block 44, Lot 4)  
Elk Township, Gloucester County, New Jersey

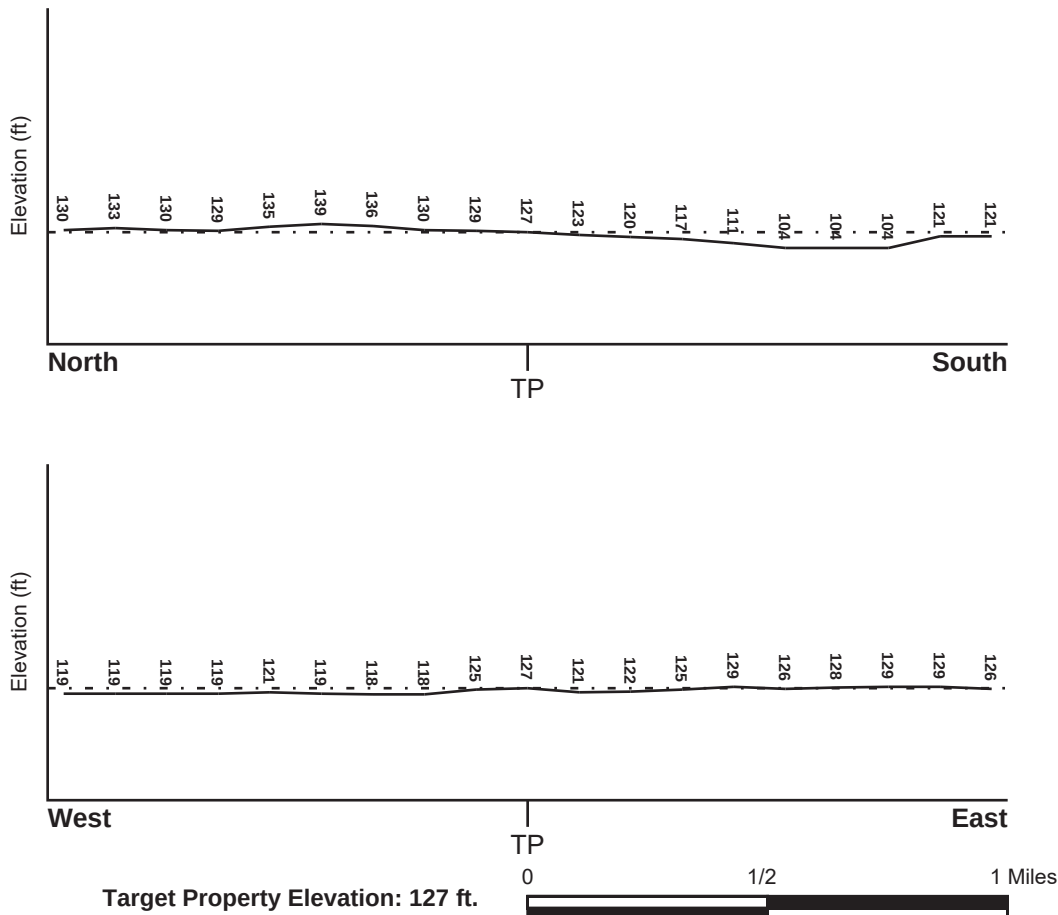
### SURROUNDING TOPOGRAPHY: ELEVATION PROFILES

General Topographic Gradient: General SSW

Source: Topography has been determined from the USGS 7.5' Digital Elevation Model and should be evaluated on a relative (not an absolute) basis. Relative elevation information between sites of close proximity should be field verified.

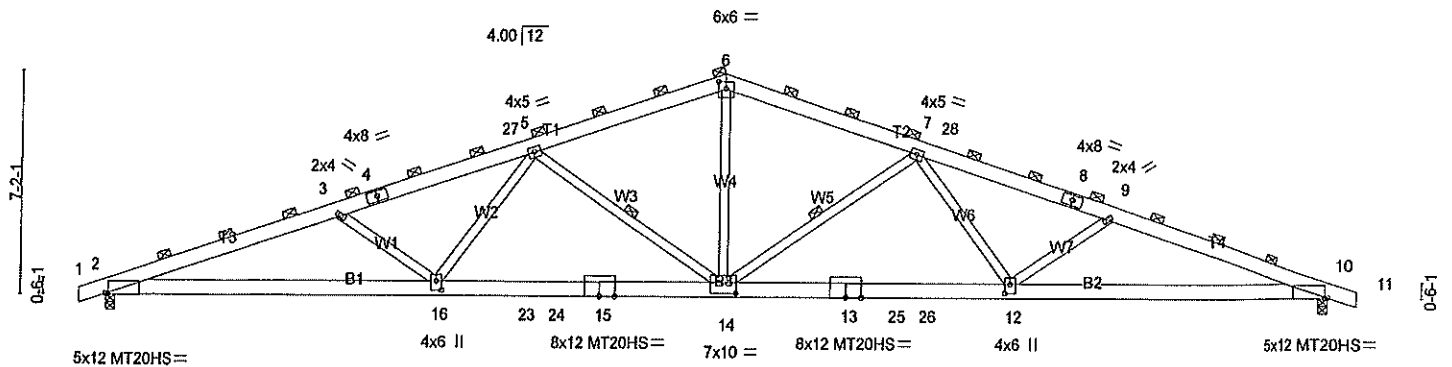
Scale = 1:71.1

0-10-8 7-6-8 13-9-4 20-0-0 26-2-12 32-5-8 40-0-0 40-10-8  
0-10-8 7-6-8 6-2-12 6-2-12 6-2-12 6-2-12 7-6-8 0-10-8

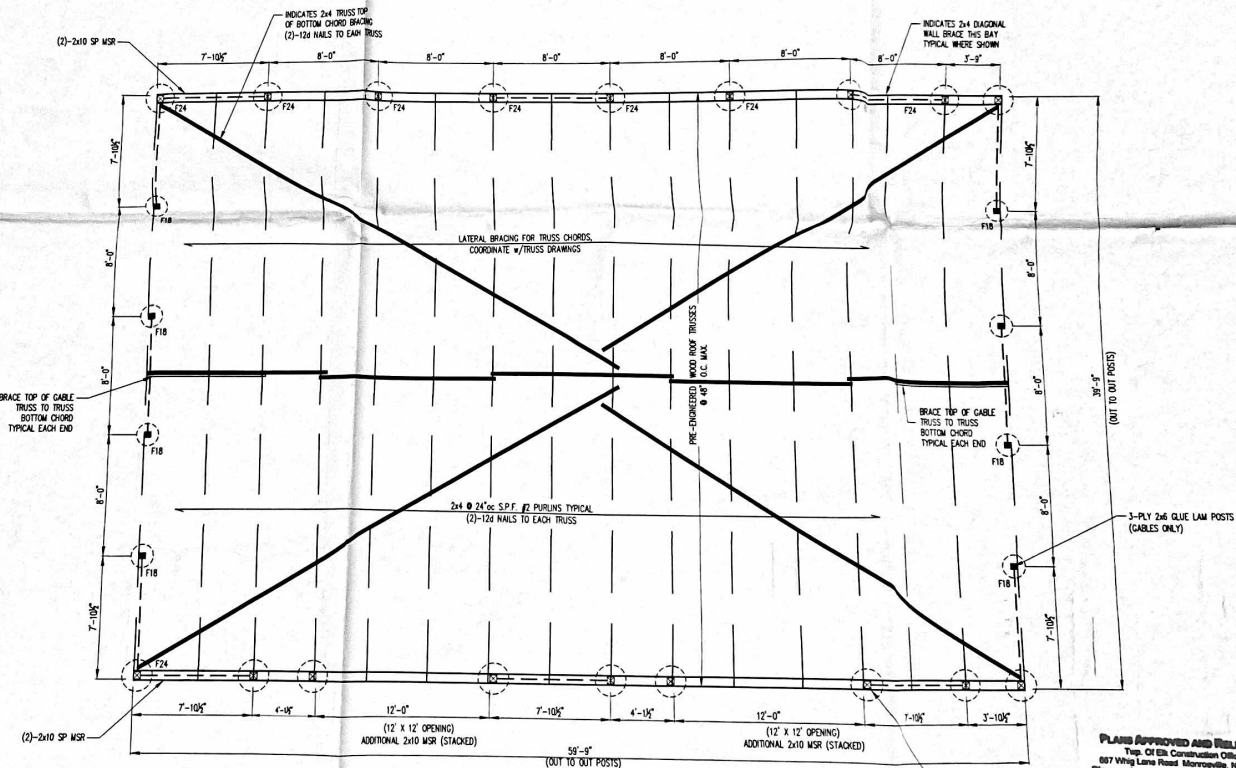
MAIN STRUCTURE - POLE BARN FRAMING PLAN  
1/4" PER FOOT

THIS PLAN INDICATES THE MAJOR STRUCTURAL ELEMENTS ONLY

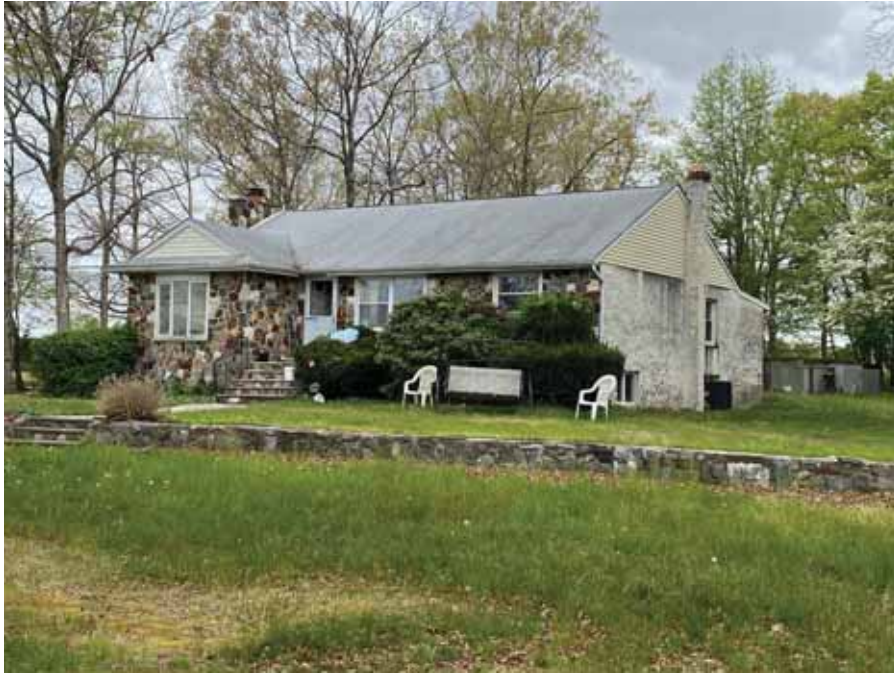
Photo 3: View of single-family residence #1 in the northeastern area of the Site.

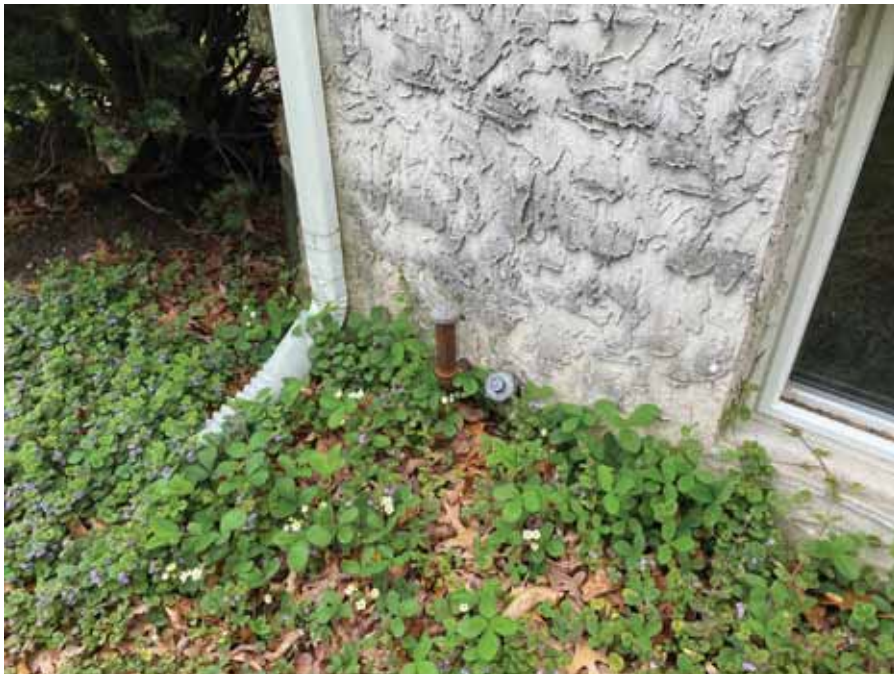
Photo 4: View of vent & fill pipes associated with a No. 2 heating oil AST situated in the basement of residence #1 onsite.

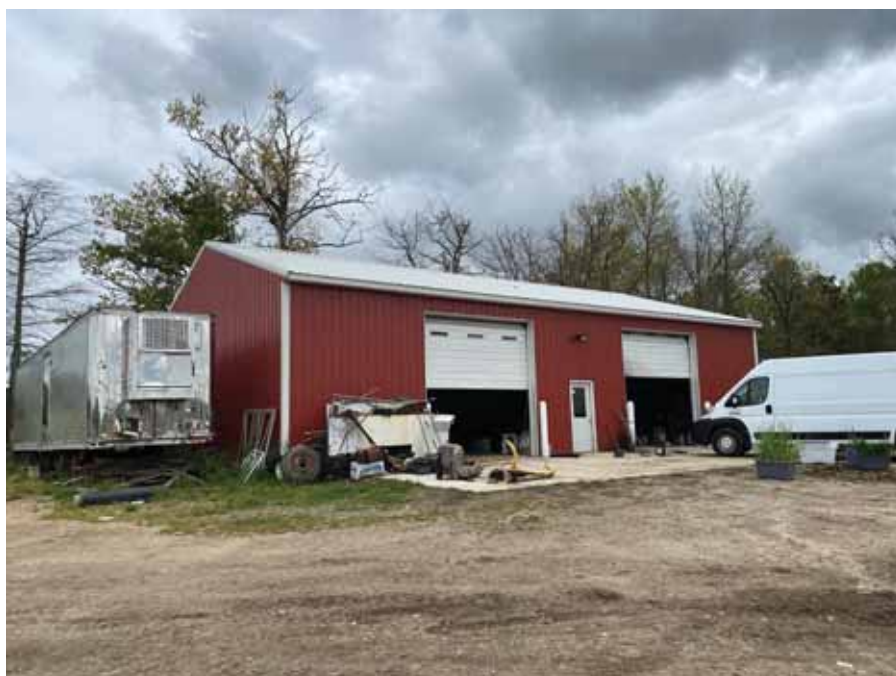
Photo 6: View of the pole barn building present in the northeastern area of the Site.

The existing pole barn building situated in the northeastern area of the Site was observed to contain a sink and toilet in the eastern interior corner of the building. Therefore, it is suspected that the pole barn building is serviced with a sanitary septic disposal system. During the May 2022 site inspection various hazardous substances and petroleum products were observed inside the pole barn building. These substances and products included but were not limited to grout & tile cleaner, insecticide, degreaser, motor oil, fuel stabilizer, lubricating oil, spray paint & enamel, brake fluid, wood stain, among others. Additionally, an area in the eastern interior corner of the building, which is present in the same location as the sink and toilet, contained several plastic containers of pesticides ranging from less than 1-gallon to up to 3-4-gallons as well as several 5-gallon buckets of motor and/or waste oil. Some of the pesticide containers were labeled as containing “Carbaryl 4L”, “Cabrio EG”, and “Prefar 4-E”. Considering the observed presence of these hazardous substances and products within the interior of the pole barn building, it is suspected that these substances and products are used, stored, handled, mixed and generated inside the building. Therefore, there remains potential for these hazardous substances and products to have been discharged to the sanitary septic system servicing the pole barn building. ***The suspected presence of a sanitary septic disposal system that services the pole barn building onsite coupled with the observed presence and suspected use, storing, handling and/or mixing of hazardous substance and products within the building, which have the potential to be discharged to the septic disposal system is considered an REC. DuBois recommends additional investigation of this REC in accordance with the applicable NJDEP regulations and guidance.***

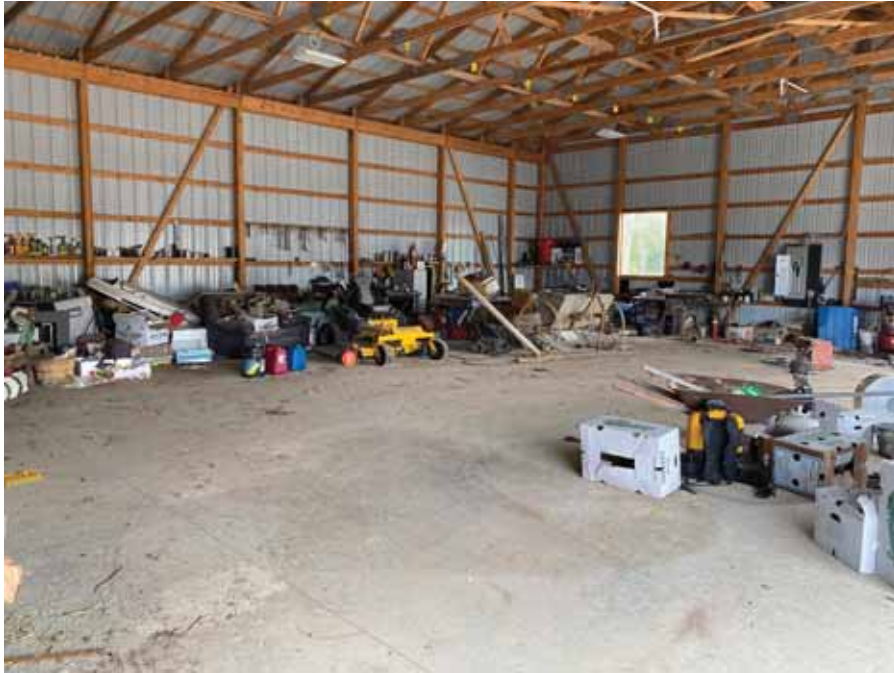
Photo 7: Representative view of the interior of the pole barn building onsite.

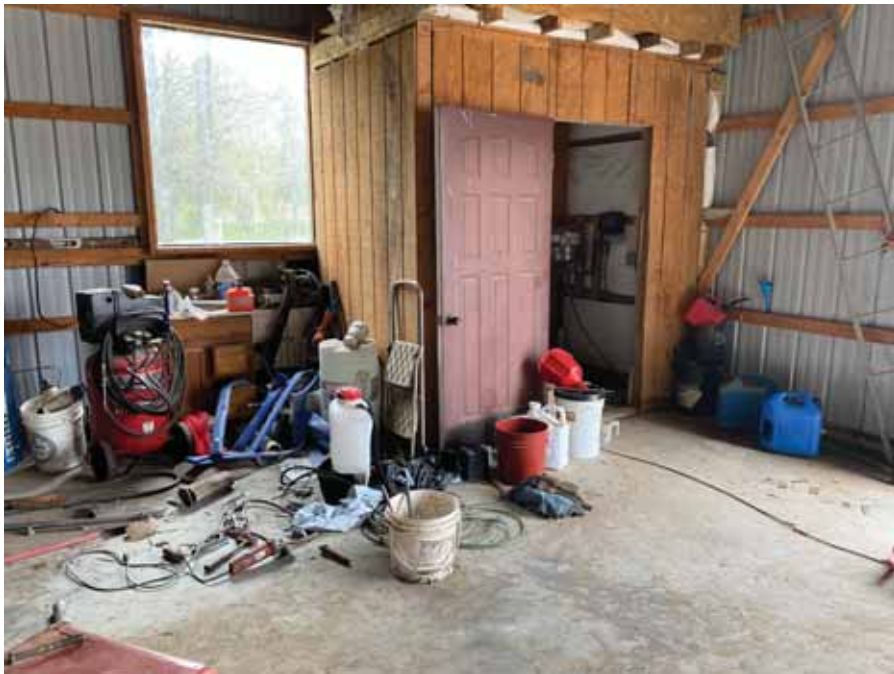
Photo 8: View of the sink and toilet area in the eastern interior of the pole barn building, which is suspected to discharge to a sanitary septic disposal system (REC-6).

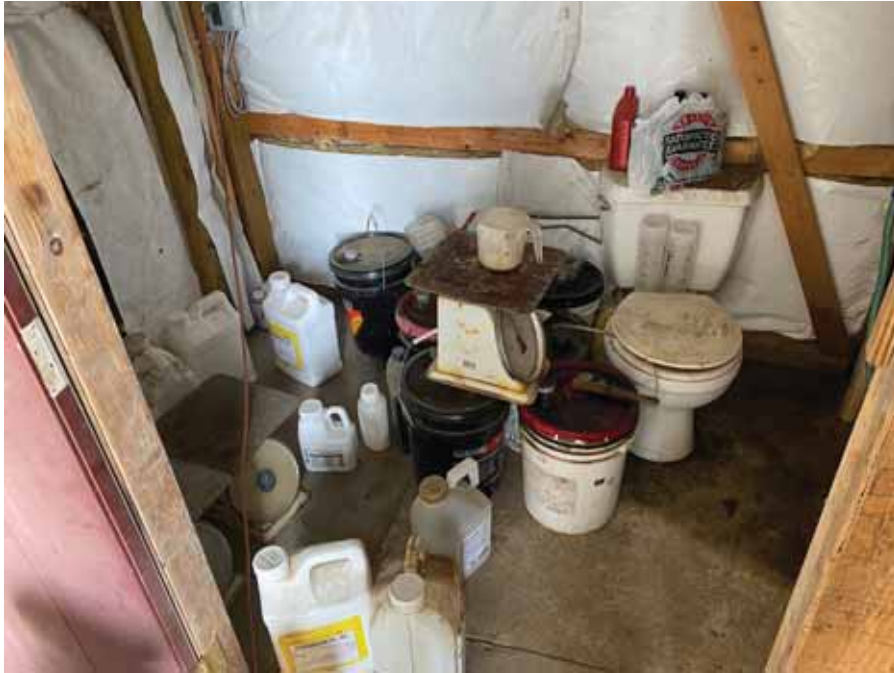
Photo 9: View of hazardous material, including pesticide and fertilizer storage located in the eastern interior of the pole barn building onsite.

During the May 2022 site inspection, various size containers and 5-gallon buckets of hazardous substance and petroleum products were observed inside of the pole barn building located in the northeastern area of the Site. The hazardous substances and products include but are not limited to grout & tile cleaner, insecticide, degreaser, motor oil, fuel stabilizer, lubricating oil, spray paint & enamel, brake fluid, wood stain, waste oil, and pesticides and fertilizers. The substances and products are suspected of being used in association with agricultural operations conducted on the Site. The containers and buckets of these materials and substances were stored on top of wood shelving and/or directly on top of intact concrete floors of the pole barn. All containers and buckets are in good condition, and no evidence of any staining and/or corrosion is observed in the vicinity of the containers and buckets. Furthermore, a few (i.e. 2-3) 55-gallon plastic storage drums containing unknown liquid were observed in the area of development present in the northeastern portion of the Site. The drums are in good condition with no sign of holes or deterioration, and no evidence of any staining, corrosion and/or stressed vegetation is observed in the vicinity of the storage drums. However, the storage drums are situated directly on top of the ground surface without any secondary containment. *All containers, drums and buckets of hazardous substances and petroleum products should be stored on top of impervious surfaces and/or within secondary containment in order to prevent future discharges/releases of hazardous substances and products from the containers, drums and/or buckets.*

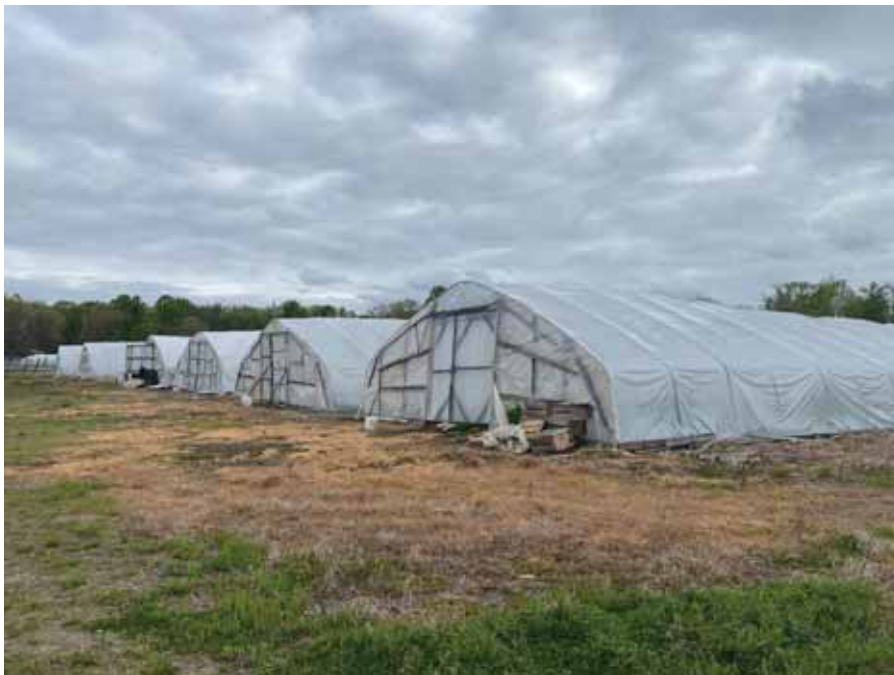
Photo 10: Representative view of the existing greenhouse buildings (REC-2) located in the eastern area of the Site.

A review of historical resources, specifically historical topographic maps and historical aerial photographs, as well as site reconnaissance performed in May 2022 revealed a series of former and current agricultural buildings onsite. Currently, a total of eight (8) greenhouses are present in the eastern area of the Site. Additional agricultural buildings were observed in the northern portion of the Site from in or around the early-1940s to sometime in the mid to late-1960s at which point they were removed. As a result, there is potential for the use, storage, handling and/or mixing of agricultural chemicals (i.e. pesticides/fertilizers) within these former and current agricultural buildings, which has potential to impact the underlying soils within those areas of the Site. The NJDEP directs the consultant to treat the use, storage, handling and/or mixing of agricultural chemicals within former and/or current buildings as a separate area of environmental concern from the use and application of agricultural chemicals during general agricultural operations. ***The presence of former and current agricultural buildings onsite, which may have involved the use, storage, handling and/or mixing of agricultural chemicals that have potential to impact the underlying soils in the vicinity of the former and current agricultural buildings, is considered an REC. DuBois recommends additional investigation of this REC in accordance with the applicable NJDEP regulations and guidance.***

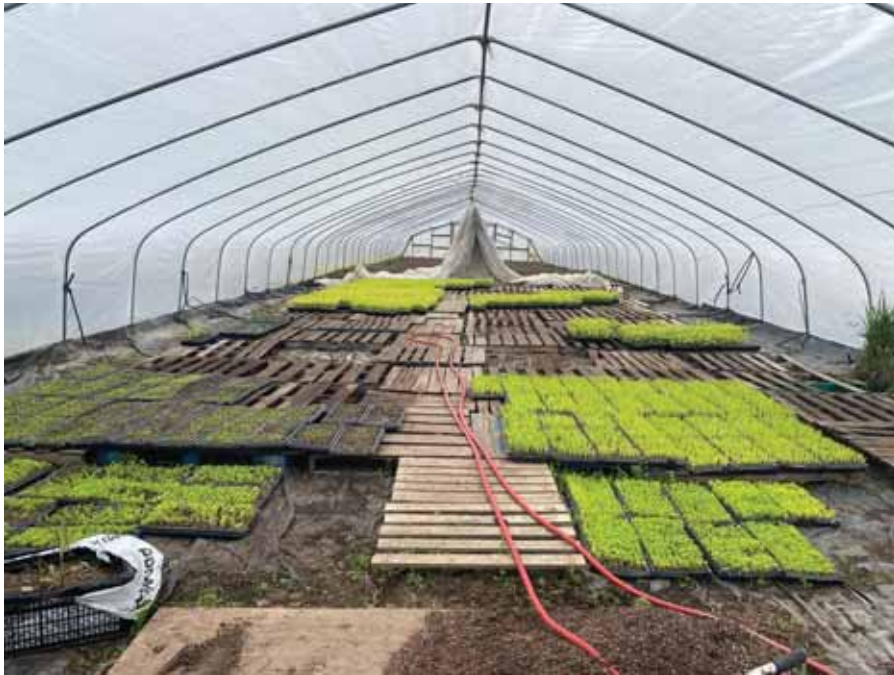
Photo 11: Representative view of the interior of a greenhouse building onsite.

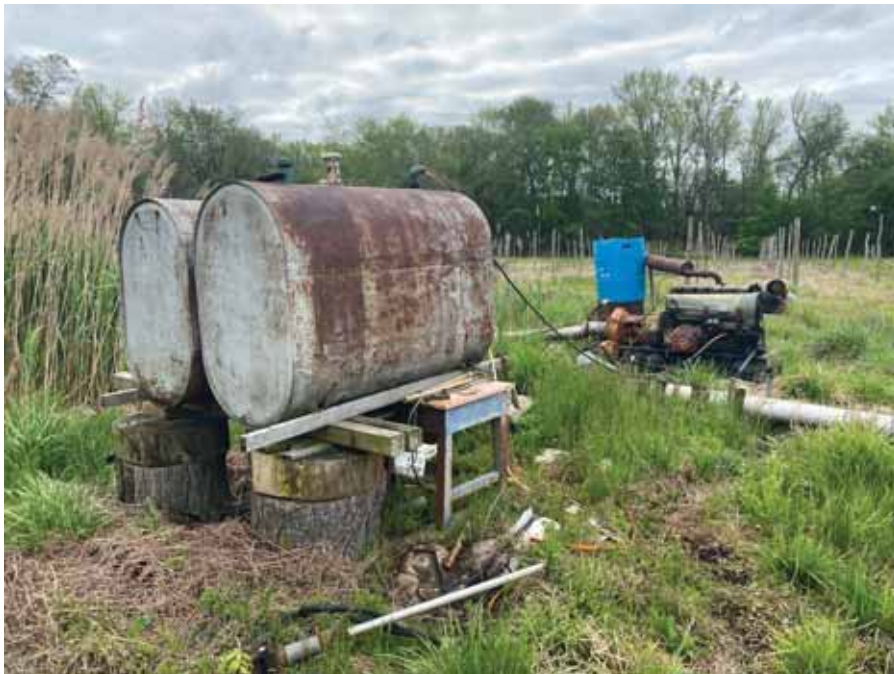
Photo 12: Representative view of an irrigation pump and associated fuel source (ASTs) located to the southwest of the man-made pond present in the eastern area of the Site.

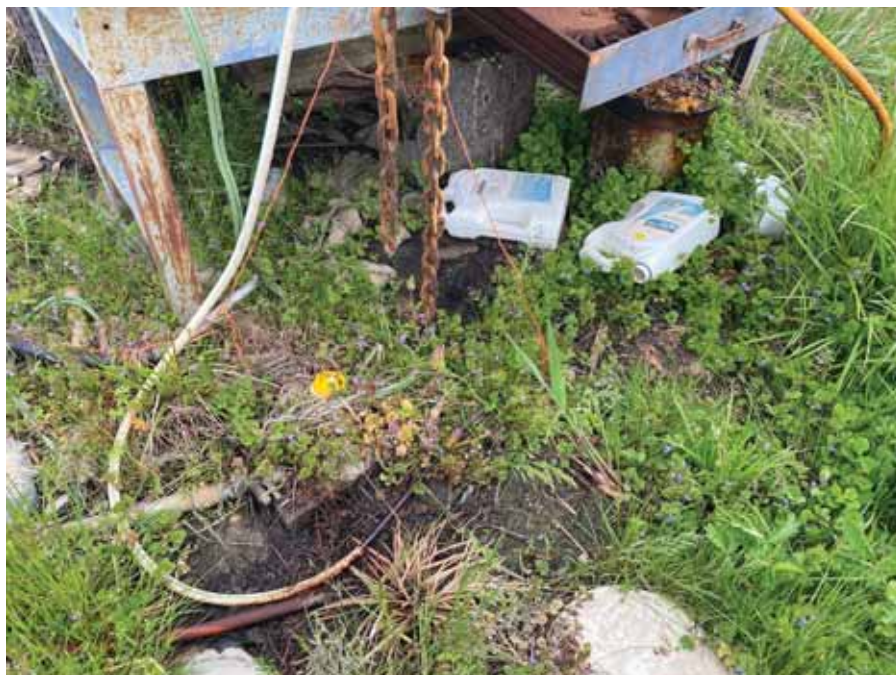
Photo 13: Representative view of the petroleum-based staining (REC-8) in the underlying vicinity of the two (2) diesel fuel ASTs pictured in photograph #12.

An irrigation pump located to the southwest of the man-made pond in the southern area of the Site consists of two (2) approximately 275-gallon steel ASTs, which are suspected to contain diesel fuel for powering the irrigation pump motor. The ASTs are situated on top of wood stumps and a steel table. Albeit rusted, the ASTs are in good condition with no sign of holes or deterioration. What appears to be some petroleum-

based staining is observed on the ground surface in the vicinity of the ASTs as well as on top of a steel plate that the motor is situated on. The staining appears to be a result of spillage during filling the ASTs as well as drippage/leakage during operation of the irrigation pump motor. ***The presence of petroleum-based staining on the ground surface directly below two (2) ASTs suspected of containing diesel fuel, which has potential to adversely impact the surface and subsurface environment of the Site, is considered an REC. DuBois recommends additional investigation of this REC in accordance with the applicable NJDEP regulations and guidance.***

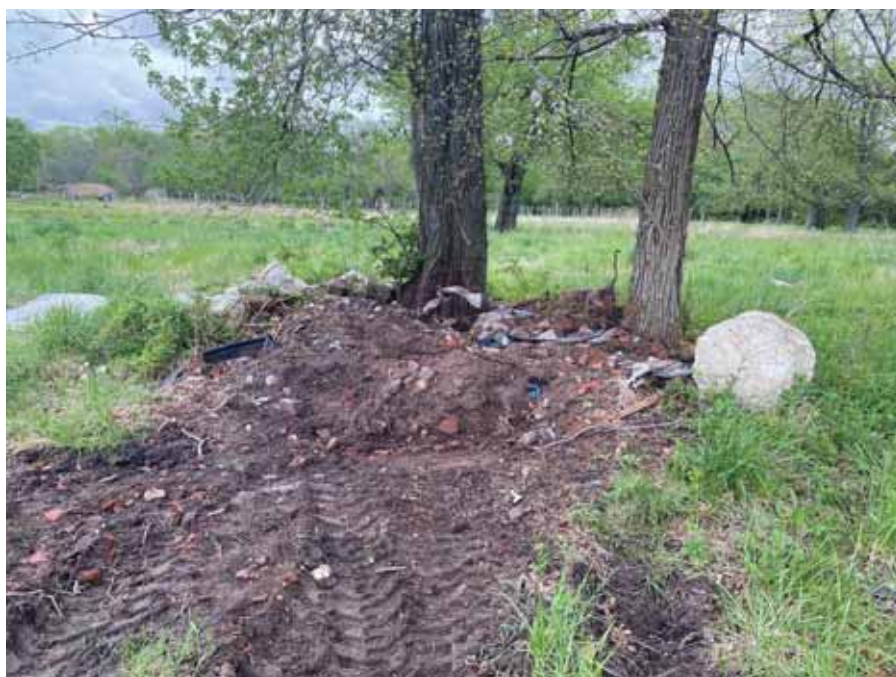
Photo 14: Representative view of suspected non-indigenous fill material (REC-3) located in the southern area of the Site.

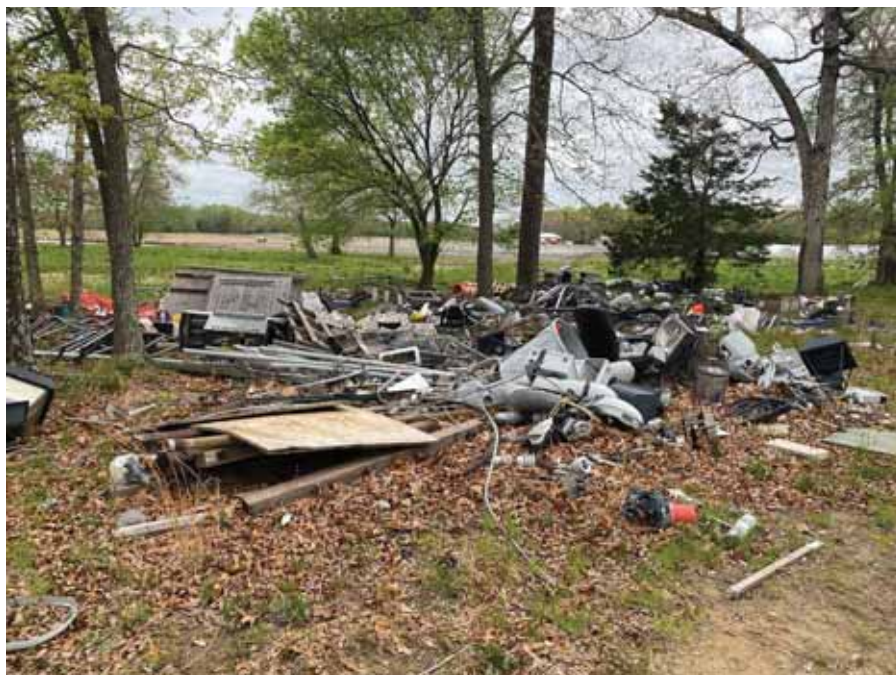
Photo 15: View of the large area of miscellaneous solid waste and debris suspected of being deposited in the southern area of the Site.

Miscellaneous solid waste and debris was observed scattered throughout the Site and predominantly in the vicinity of the development in the east and northeastern areas of the Site as well as an area located in the southern portion of the Site. The miscellaneous debris includes but is not limited to an old farm equipment (i.e. plows, etc.), tires, concrete rubble, empty propane tanks, metal scraps, plastic and rubber hose and pipes, wood pallets and scraps, metal irrigation pipes, electrical components (i.e. insulators, wires, switches, conduit pipes, etc.), old televisions and computers, furniture, plastic scraps and so on. The debris appears to have been accumulated over time as a result of historic and current agricultural operations. However, the area of debris present in the southern portion of the Site appears to have been a result of dumping. No evidence of any staining, corrosion and/or stressed vegetation was observed within the vicinity of the solid waste and debris. *All existing miscellaneous solid waste and debris should be properly removed and disposed offsite. During removal activities, should evidence of a discharge be identified, at that time, additional investigation may be necessary.*

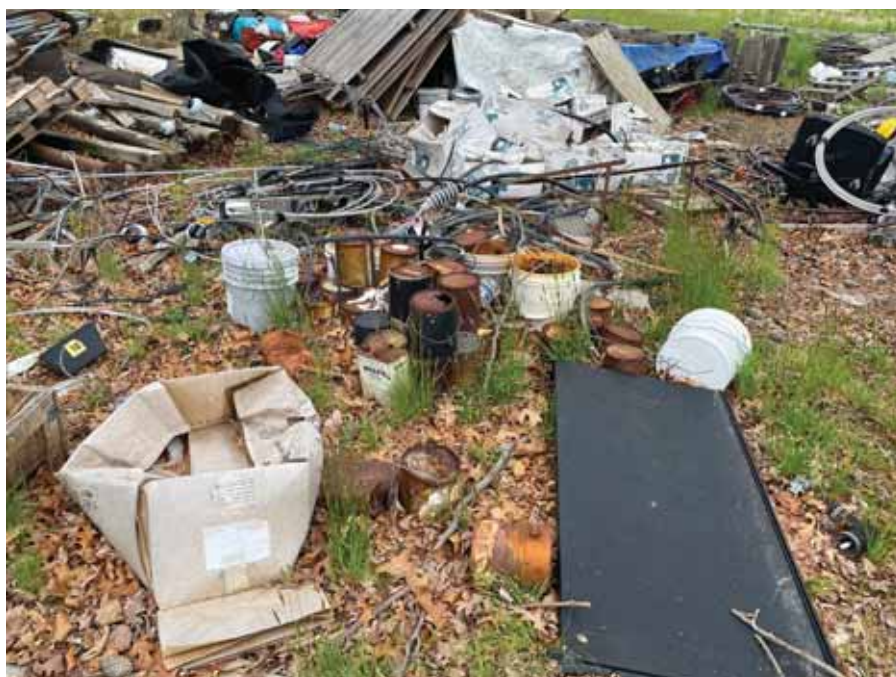
Photo 16: View of the potential hazardous material disposal (REC-5) co-located with the above-referenced miscellaneous solid waste and debris present in the southern area of the Site.

An area that measures approximately 10-feet by 10-feet and is co-located with a large area of deposited miscellaneous solid waste and debris present in the southern area of the Site contains approximately 15-20 retail-size (< 1-gallon) steel containers of paints and enamels. The containers are rusted and some of them have holes and/or corrosion along the top. The containers appear to be either empty and/or contain residual amounts of paints and enamels. While no direct evidence of any staining, corrosion and/or stressed vegetation is observed in the vicinity of the containers, there remains potential for previous discharges/releases of those hazardous materials to the underlying ground surface of the Site. ***The presence of containers labeled as containing various paints and enamels, which show sign of corrosion, holes and deterioration, which have potential to discharge/release hazardous substances to the surface and/or subsurface environment of the Site, is considered an REC. DuBois recommends removal and offsite disposal of these containers followed by additional investigation of this REC in accordance with the applicable NJDEP regulations and guidance.***

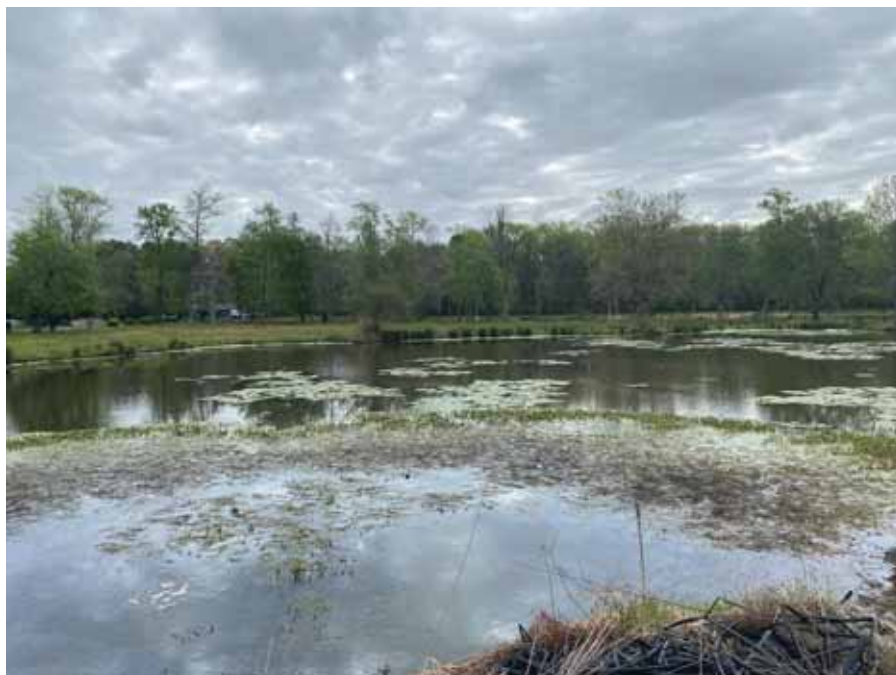
Photo 17: Representative view of one (1) of the man-made ponds present in the eastern portion of the Site.

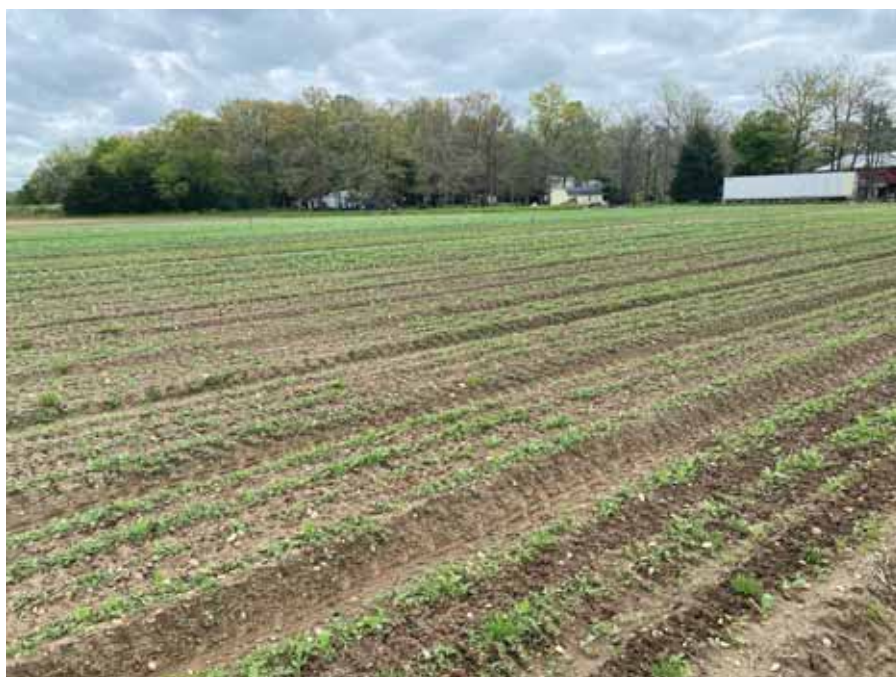
Photo 18: Representative view of the existing agricultural farm fields (REC-1) onsite.

Based on a review of historical resources, specifically historical aerial photographs, as well as site reconnaissance performed in May 2022, the majority of the Site has historically been used for agricultural purposes associated with crop cultivation since at least circa 1931. The Site is currently used for agricultural purposes associated with crop cultivation activities. As a result of those former and current agricultural operations performed onsite, pesticides/herbicides may have been applied on-site during those agricultural operations, and therefore, there is a potential for the underlying soils of the Site to be impacted by these past and current agricultural operations. Pursuant to the NJDEP's Historically Applied Pesticide Site Technical Guidance, Version 3.1 and dated February 2022, the requirement for further investigation (i.e. sampling investigation) and/or remediation of Historically Applied Pesticides ("HAP") may be deferred unless or until there is a change in use to school, child care and/or residence, if there is a newly identified Immediate Environmental Concern ("IEC") condition and/or should native soils of the site be proposed for transportation/relocation off-site. ***The historical and current use of the Site for agricultural purposes coupled with the likely application of pesticides during this operational use is considered an REC. In the event any of the aforementioned scenarios arise and/or should agricultural operations be***

***proposed to cease, at that time, DuBois recommends additional investigation of this REC in accordance with the applicable NJDEP regulations and guidance.***

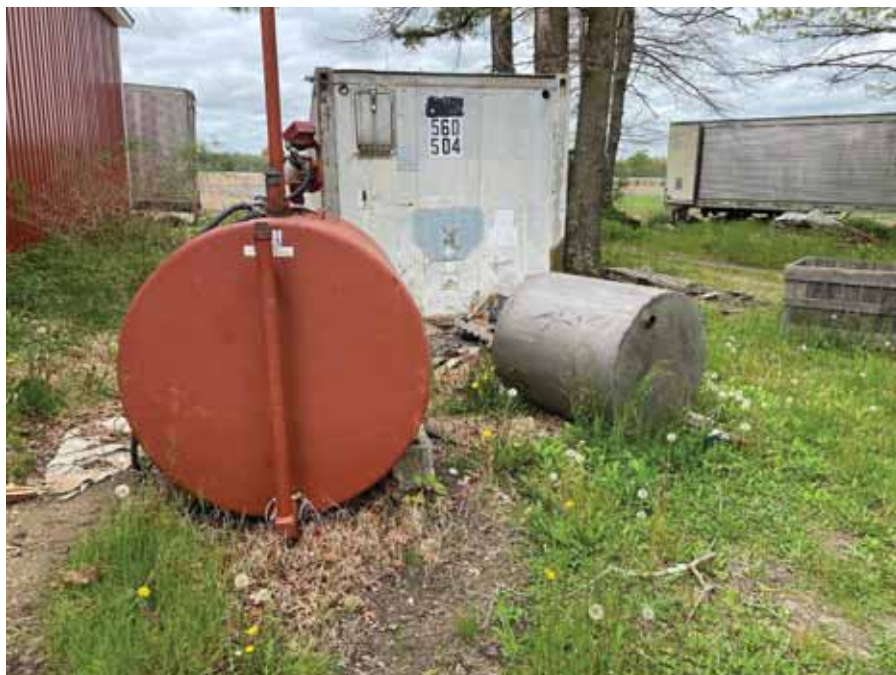
Photo 19: Representative view of empty steel ASTs present in the northeastern area of the Site.

During the May 2022 site inspection seven (7) ASTs were identified on the subject Site. One (1) of the ASTs included an approximately 275-gallon No. 2 heating oil AST, which is situated in the basement of residence #1 and is used as a fuel source for heating the residence. The heating oil AST is situated on top of intact concrete floors of the basement with no sign of staining and/or corrosion, and therefore, this AST shall not be grouped with the remaining ASTs referenced herein. Two (2) approximately 275-gallon ASTs suspected of containing diesel fuel are located in the vicinity of an irrigation pump situated to the southwest of the man-made pond in the eastern area of the Site. These ASTs are suspected of being a fuel source for powering the irrigation pump motor. Evidence of petroleum-based staining was observed in the underlying vicinity of these two (2) ASTs. An approximately 275-gallon empty AST was observed in a partially forested area situated in the southern portion of the Site. Additionally, three (3) other empty ASTs varying in size from approximately 290-gallons to 550-gallons were observed in the vicinity of the residences and pole barn building present in the northeastern area of the Site. These four (4) ASTs appear to be empty, are in good condition with no sign of holes or corrosion and no evidence of any staining, corrosion and/or stressed vegetation was observed in the vicinity of the four (4) ASTs. The four (4) ASTs are suspected of formerly being used

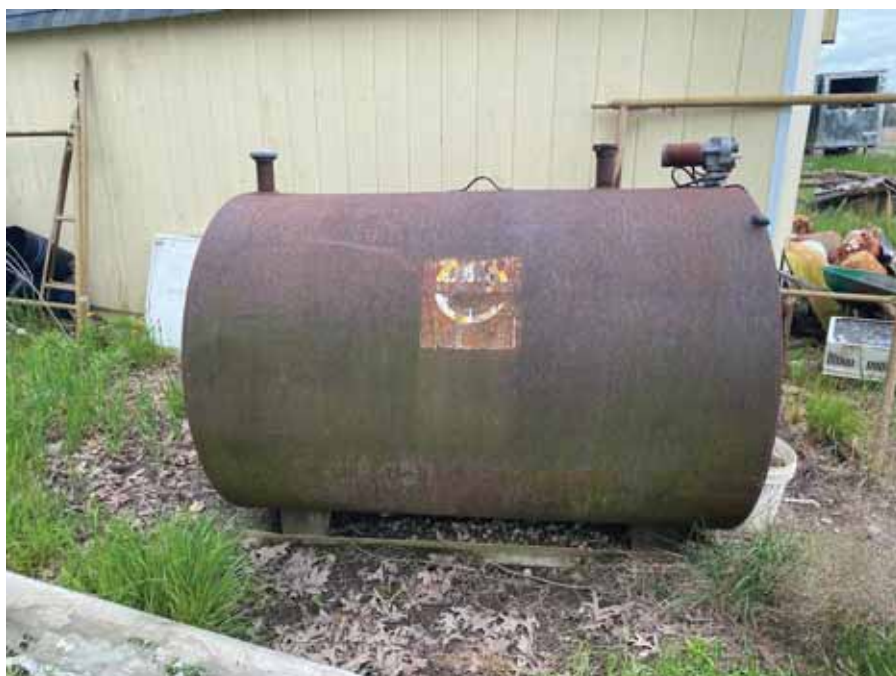
Photo 20: Additional view of an empty steel AST located in the northeastern area of the Site.

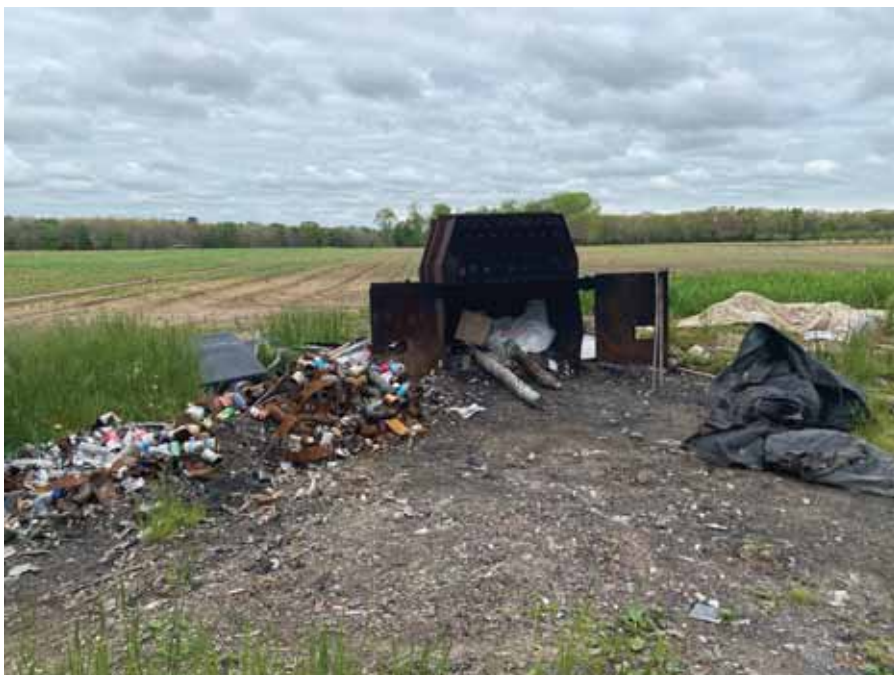
Photo 21: View of the debris/garbage burning area (REC-7) located in the northeastern area of the Site.

A steel enclosure, which appears to be used to burn garbage/debris is present along the eastern side of the agricultural farm fields situated north-northwest of the pole barn building onsite. Ash and pieces of garbage were observed in and within the vicinity of the steel enclosure. Burning of garbage/debris is known to result in the release of various hazardous contaminants to the surrounding environment, which are often harmful to human health and the environment. ***The observed presence of a designated area for the burning of garbage/debris coupled with the observed presence of ash and black soot material on the ground surface, which has potential to adversely impact the surface and subsurface environment of the Site, is considered an REC. DuBois recommends additional investigation of this REC in accordance with the applicable NJDEP regulations and guidance.***

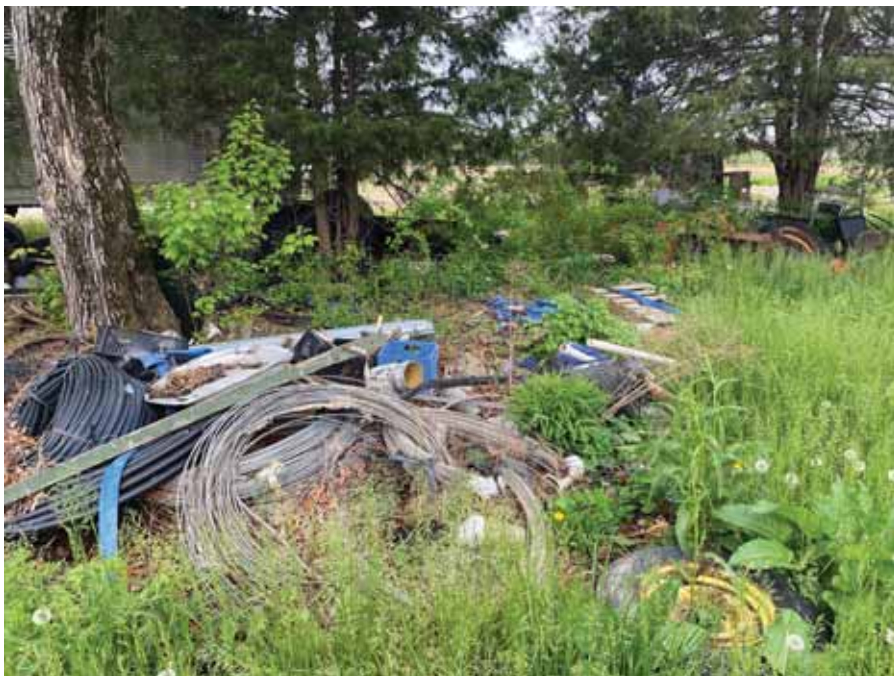
Photo 22: View of miscellaneous solid waste and debris scattered in the area of the buildings present in the northeastern area of the Site.

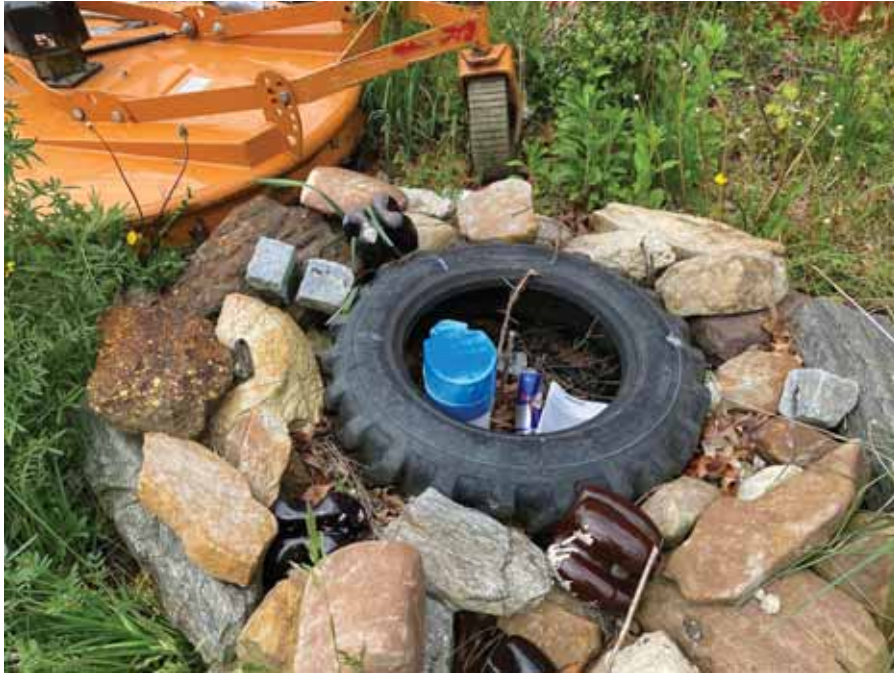
Photo 23: View of a private potable well situated outside the eastern exterior of the pole barn building onsite.

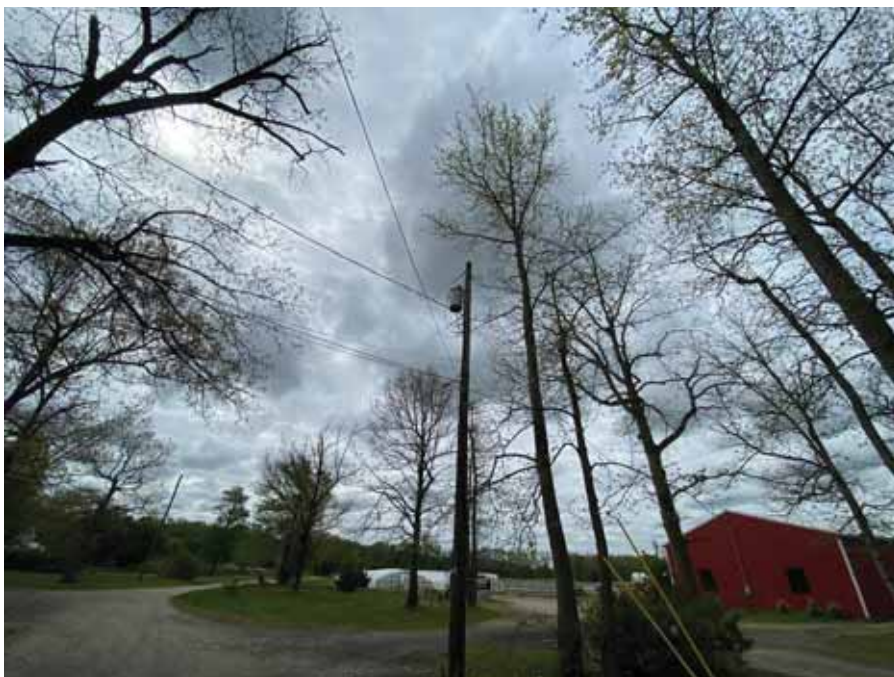
Photo 24: Representative view of an existing pole-mounted electrical transformer present on the Site.
